Ram Pump Water Filtration: Assessment and Filtration in Tres Hermanos

Jonathan Lamano

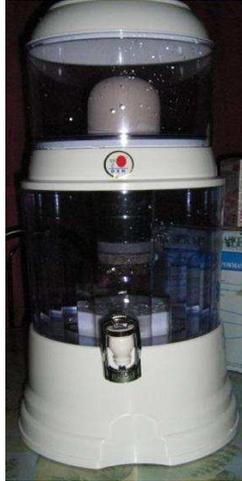
Figure 1: Megafresh Commercial Filter Used During the Project Duration

Filter Option	Assessment
In-Line Filtration System	Discussed with AIDFI, but ultimately decided against due to the necessary appointment of a local water quality technician, who would assume responsibility for the water supply of the entire village population. Repair of the system would also require more tools and expertise. AIDFI would rather leave water quality as a family responsibility. Not recommended.
Commercial Filters (See Figures 1 and 2)	Commercial filters were used during the trip, yet for the average rural family, they are too expensive to purchase. Moreover, they are difficult to transport from the markets where they are sold and in the occurrence that they break down (sometimes frequently) or need replacement filters, the parts are expensive and difficult to attain. Not recommended.
SODIS	Method currently implemented by some rural villages due to its ease of operation. PET and glass bottles are easily accessible even in the rural villages. Currently, Red Cross volunteers and DOD volunteers are spreading knowledge of the water purification method. This method is highly recommended for use in the rural Philippines.

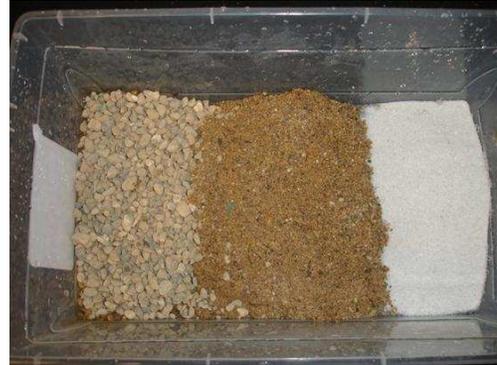
Figure 3: Grades of Sand and Gravel Used to Construct Biosand Filters

Household Biosand Filtration Systems (See Figures 3, 4, and 5)	No household biosand filtration systems were encountered in the Philippines, however, all of the necessary components of the filter- cement or plastic buckets, gravel, and sand - are easily accessible and even plentiful in the rural areas. A biosand filter was constructed at Northwestern and tested (See Table 5). Biosand filtration systems are highly recommended.
Porous Ceramic Filtration (See Figure 6)	The only porous ceramic filters encountered in the Philippines were commercially made filters. Clay sources were abundant in some rural areas, however, no ovens for clay firing were spotted, nor did any rural Filipinos report pottery experience, as they mainly work with weaving bamboo baskets. Porous ceramic filters were constructed at Northwestern and tested (See Table 6). However, even with the expertise and aid of a professional potter at ARTica Studios, the filters were fragile and difficult to construct. Therefore, they are not highly recommended for Filipino rural areas.

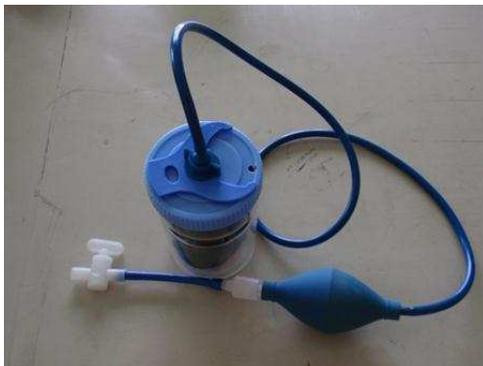
Figure 2: Commercial Hand Pump Tested in the Philippines

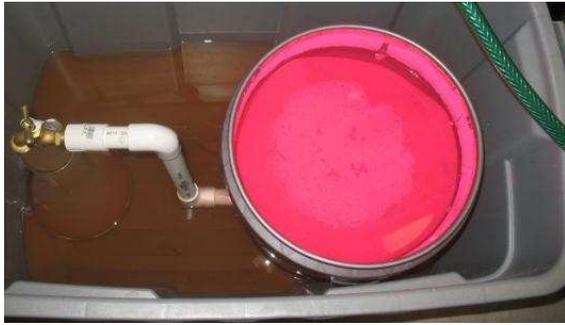
Figure 5: Testing the Biosand Filtration System

Test run using fluorescent particles of size approximately 5 micrometers to mimic water contaminants

Time of Sample Collection	Concentration (counts/mL)
7:12 P.M (Initial Concentration)	13,728,726.64
7:32 P.M (20 minute interval)	1,371,209.95
8:12 P.M (1 hour interval)	1,790,547.69
8:42 P.M (1 hour and 30 minute interval)	21,594.824

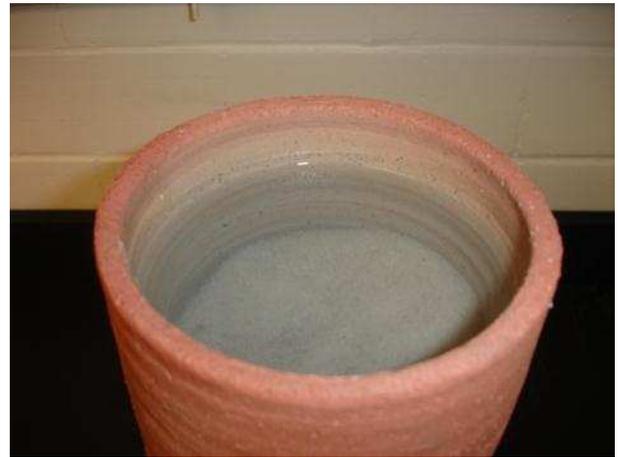
Figure 7: Combination Porous Ceramic and Biosand Filter

Porous Ceramic/Biosand Filtration Combinations (See Figures 7 and 8)	The combination of the two filters was hypothesized to facilitate greater overall purification and filtration. The filter combinations were prototyped and tested at Northwestern. However, for the same reasons as the porous ceramic filters, they cannot be highly recommended for communities in the rural Philippines.

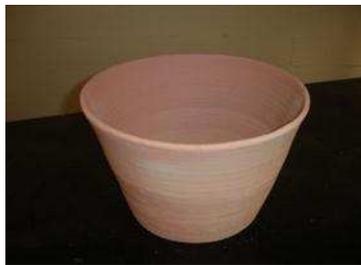
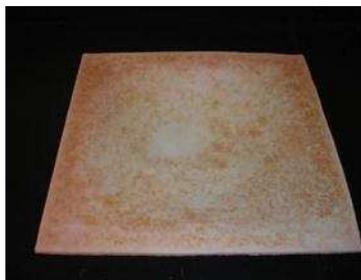
Figure 6: Configurations of Porous Ceramic Filters

Filter Prototype	Maximum Capacity (mL)	Flow Rate (mL/min)
Plate	800	0.824
Pot	13,500	6.579
Cylinder	23,000	0.870

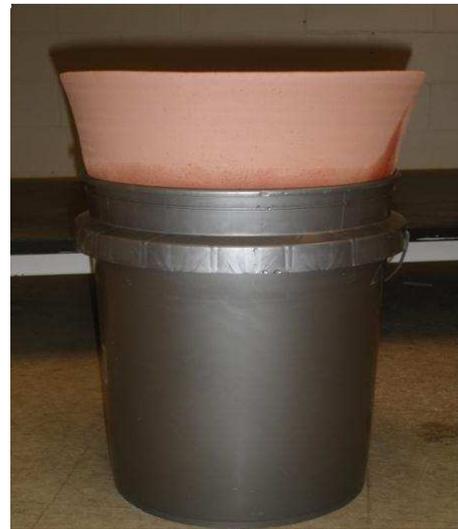
Figure 8: Alternate Configuration of Porous Ceramic and Biosand Combination
